Cingo Residential Home Inspection

2414 US-280, Lyons, GA 30436

February 06, 2025 09:00 am

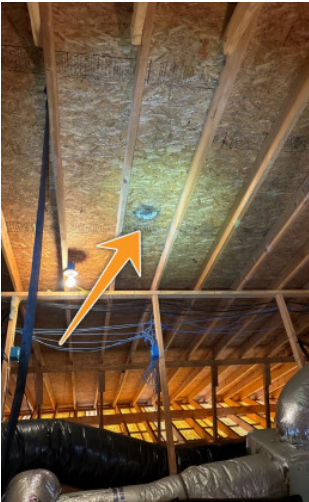
DEFICIENCY 2.1

Stained Roof Decking / Framing

Monitor, Future Repair: Stained and possibly rotted roof decking and/or framing was noted in the attic which appears to have been caused by previous roof leaks. This material should be checked for damaged when re-roofing and replaced as necessary.

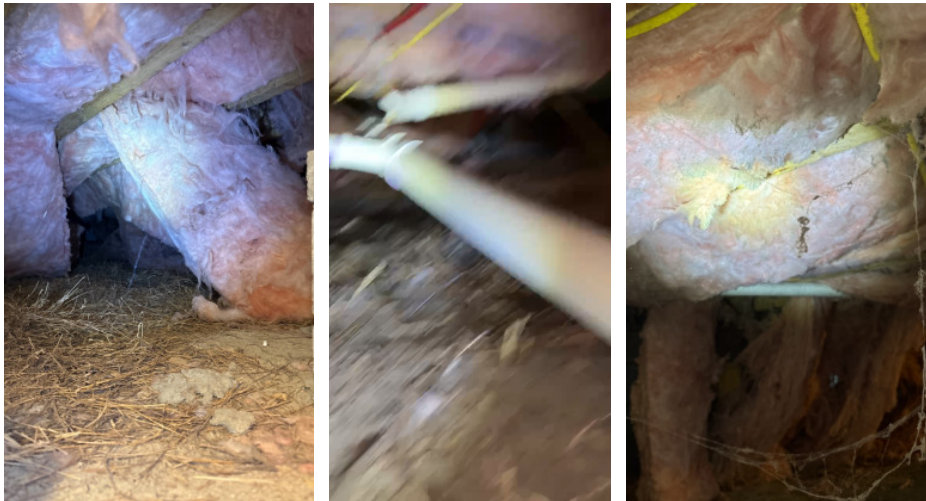
LIMITATION 4.1

Crawlspace Access Limited

Monitor: Crawlspace access was limited at the time of inspection due to insufficient access, plumbing/ductwork, stored items, or debris. Proper access to the entire crawlspace is important for monitoring for structural issues, water leaks, and termite or pest activity. Ensure proper access to the crawlspace and inspect the area thoroughly.

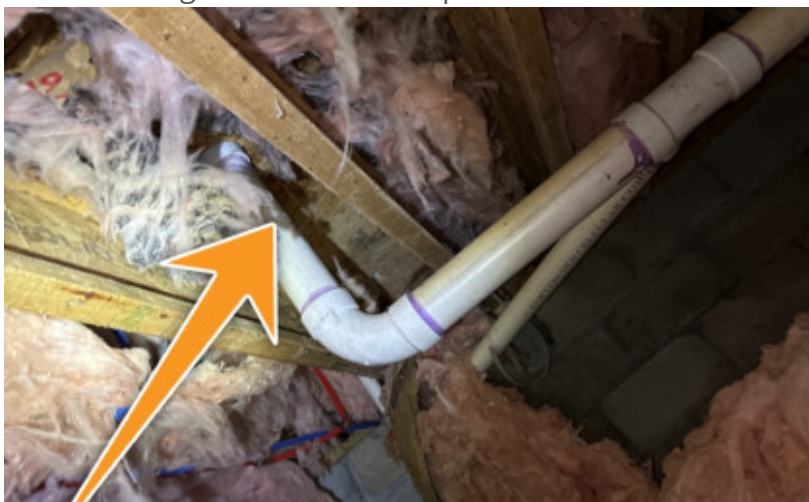
DEFICIENCY 4.2

Water Damage / Rot Noted - Repair

Repair: The floor structure as noted shows evidence of advanced water damage and rotting.

Rot weakens the structure and can cause building settlement. Damaged wood should be repaired or replaced and the conditions that have promoted the rot should be corrected. Consult a qualified framing contractor for further evaluation and options for repair, as well as prevention of future damage.

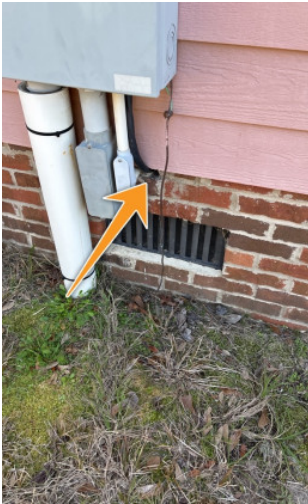
DEFICIENCY 6.1

Penetrations Missing Sealant

Repair: Penetrations through the veneer for mechanical and electrical components should be sealed with mortar to prevent water, rodent and insect entry. Foam is a poor sealant as it can be chewed through by rodents and deteriorates in the presence of UV rays. Seal around the penetration with silicone caulk or mortar.

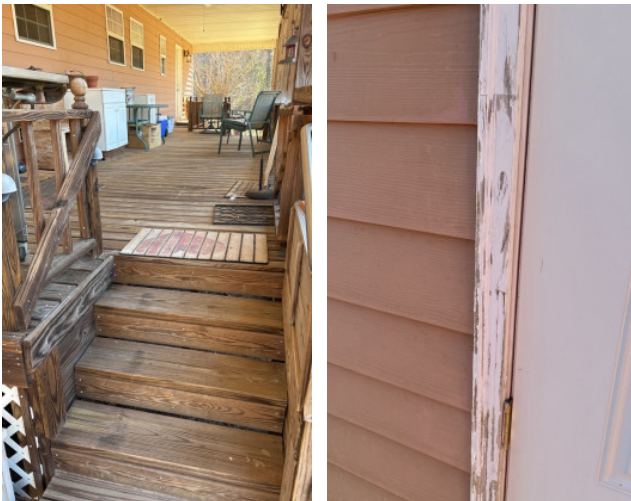
DEFICIENCY 6.2

Paint Exterior Wood Trim

Monitor, Future Repair: The exterior wood trim components will need caulking and painting in the near future to prevent future damage to this material. Any damaged wood should be repaired or replaced as needed. Make sure all holes in the siding and trim are filled and sealed. All utility penetrations (e.g. piping, vents, and light fixtures) should be properly caulked to prevent moisture intrusion.

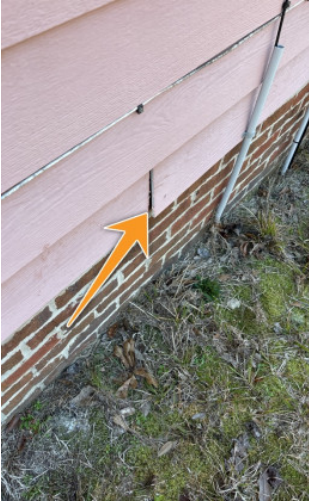
DEFICIENCY 6.3

Loose Siding Noted

Repair: Loose siding was noted, especially at the location(s) shown, which should be re-nailed and secured to prevent moisture and possible rodent intrusion into the structure. All nail holes, butt joints, and other openings in the siding should be caulked and sealed.

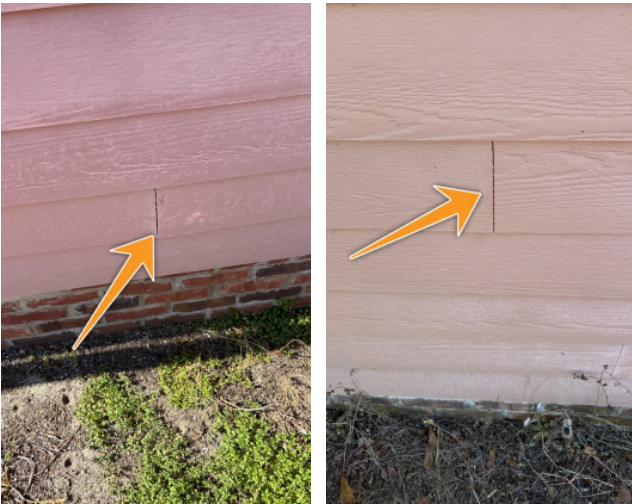
DEFICIENCY 6.4

Caulking Gaps at Exterior Veneer

Repair: Gaps and openings in any veneer can allow water penetration into the wall cavity. Properly caulk or grout all gaps in the exterior veneer, paint as needed.

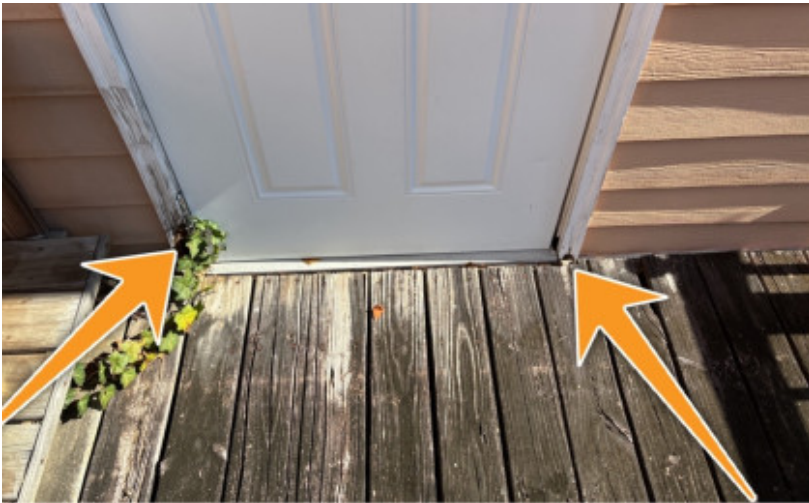
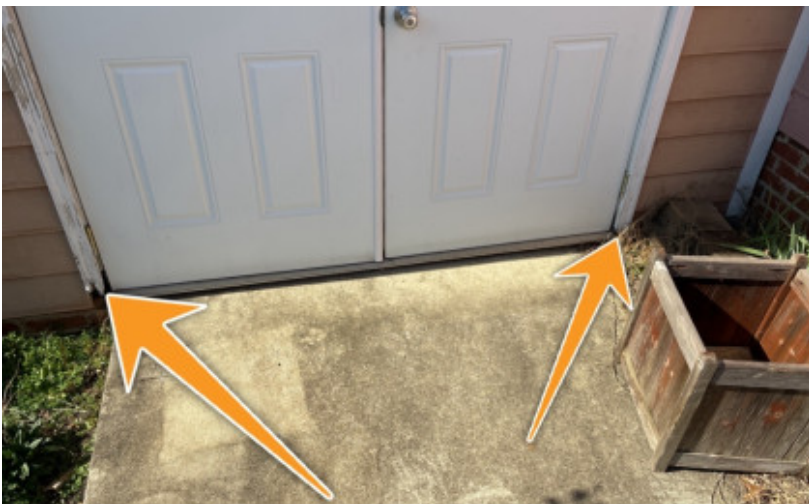
DEFICIENCY 6.5

Damage Noted At Door Frame

Repair: Damage was noted at the door frame. Consult a carpenter or qualified handy person for further evaluation and repair.

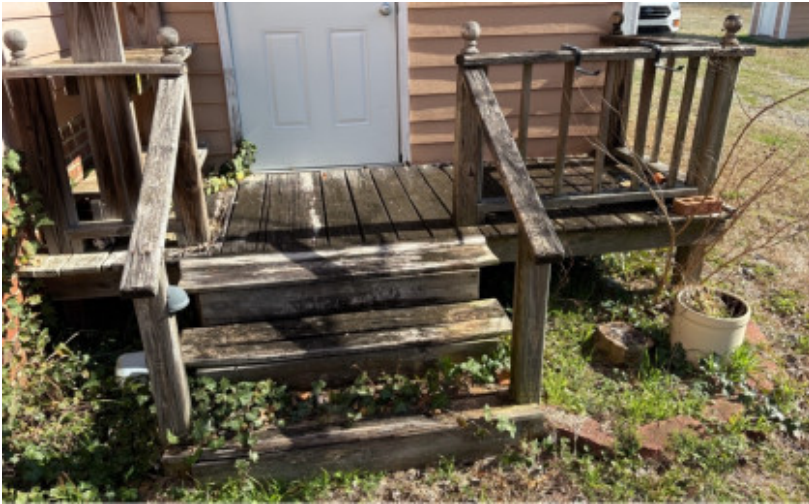
DEFICIENCY 6.6

Deck Repairs Needed

Repair, Safety Issue: Repairs are recommended at the rear wood deck for proper safety, which should be performed by a qualified framing or deck contractor. The contractor should assess all components for proper performance and safety.

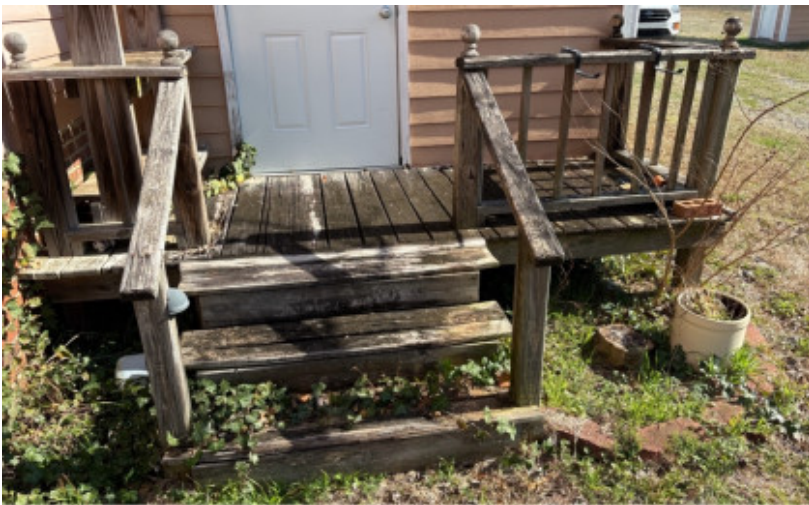
DEFICIENCY 6.7

Deck Paint / Stain Needed

Improve: The wood deck should be power-washed and then painted or stained to improve durability and protection against further weather damage.

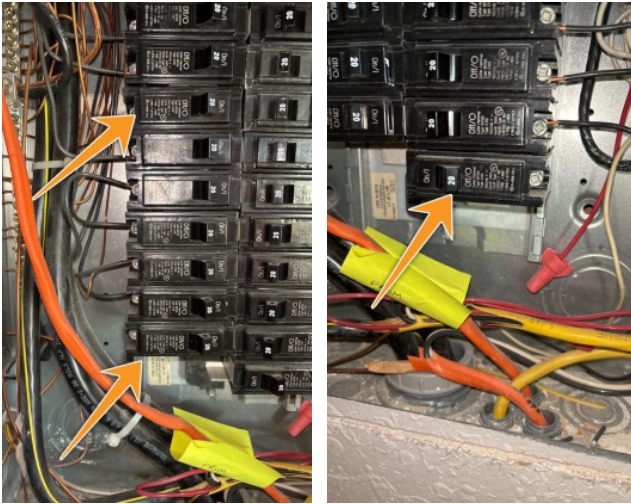
DEFICIENCY 7.1

Unused Breakers Noted

Monitor: Unused breakers were noted in the main panel. If these are functioning properly (have electrician check), they can be used for future electrical needs and expansion.

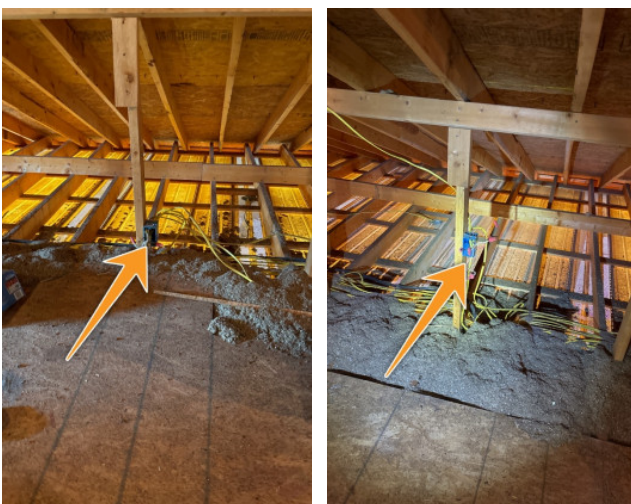
DEFICIENCY 7.2

Cover Missing At Junction Box

Repair: All open junction boxes as noted should be fitted with cover plates.

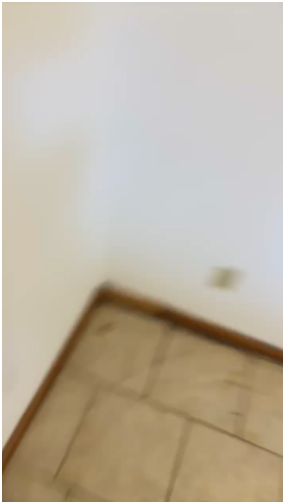
DEFICIENCY 7.3

Inoperative Outlet

Repair: An outlet as noted appears to be inoperative and/or did not respond to the wall switch in the room. Consult with the seller concerning its operation and have repaired as necessary.

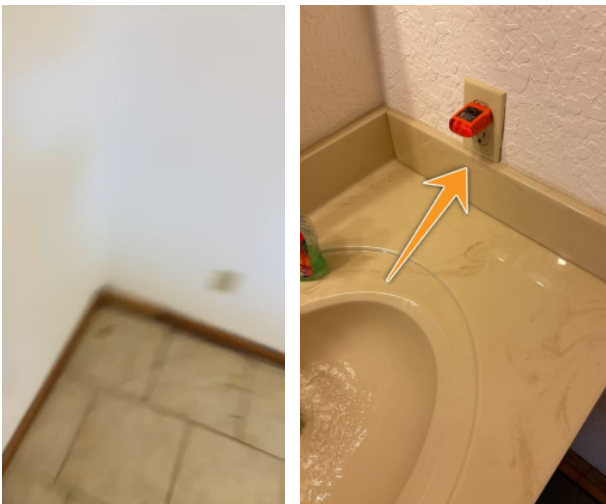
DEFICIENCY 7.4

Loose Outlet

Repair: Loose outlet(s) as noted should be tightened to prevent the loosening of the wiring connections in the future.

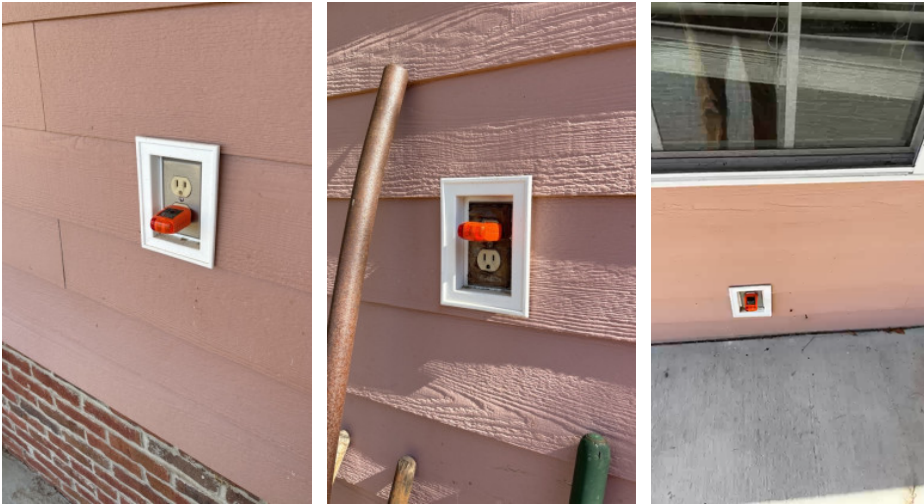
DEFICIENCY 7.5

Exterior Outlets Need Weatherproof Covers

Improve: Up to date and tighter weatherproof covers should be installed on the exterior outlets as noted to prevent moisture intrusion and damage to the wiring.

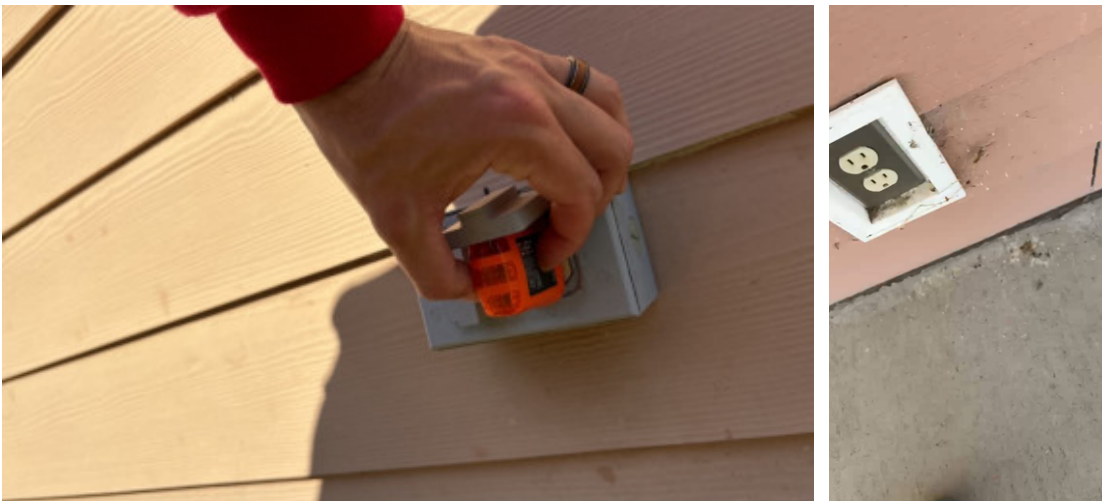
DEFICIENCY 7.6

GFCI Recommended

Improve, Safety Issue: The installation of a ground fault circuit interrupter outlet(s) is recommended at the location(s) shown. A ground fault circuit interrupter (GFCI) offers increased protection from shock or electrocution. Up to date weatherproof covers should be installed at all exterior outlets.

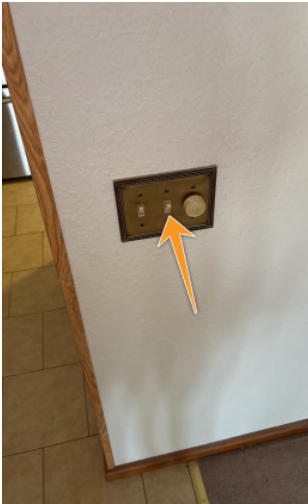
DEFICIENCY 7.7

Unknown Switch Function

Monitor, Possible Repair: We were unable to determine the function of all switches. Consult seller as to use of switches. Consult an electrician as necessary.

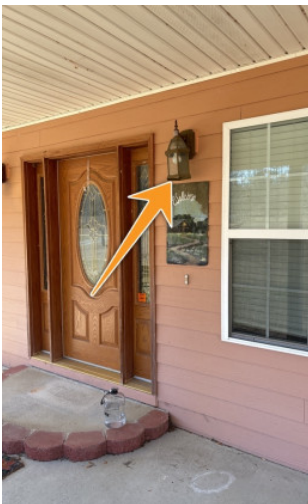
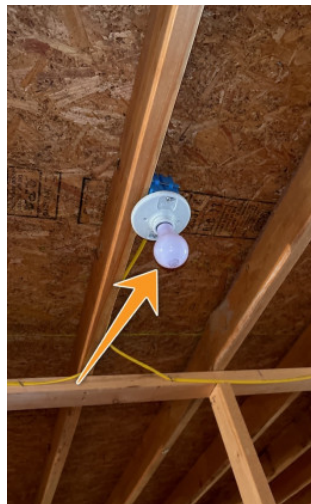
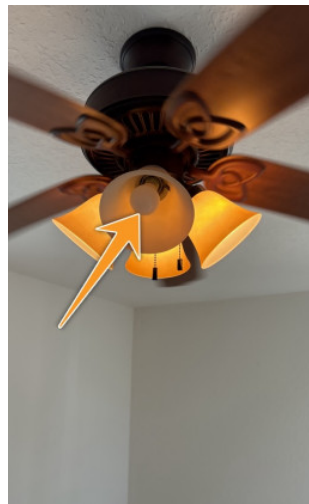
DEFICIENCY 7.8

Lights Not Operative

Monitor, Possible Repair: Some of the lights did not come on with the wall switches as noted. First replace the bulb and see if the fixture will operate, if not have an electrician check all lighting fixtures for operable bulbs and then check circuits for proper operation. Consult with the seller concerning all switch locations and/or automatic switches that may be controlling the lights and ceiling fans, if any.

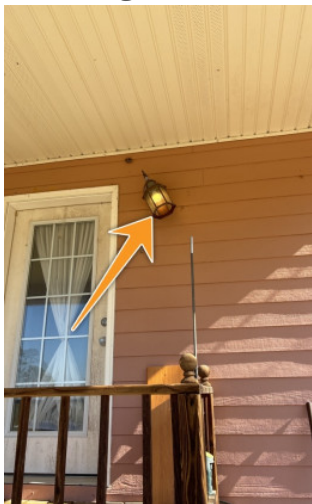
DEFICIENCY 7.9

Loose Light Fixtures

Repair: Loose light fixtures as noted should be tightened and properly mounted to prevent exposure of the wiring and loosening of wiring connections.

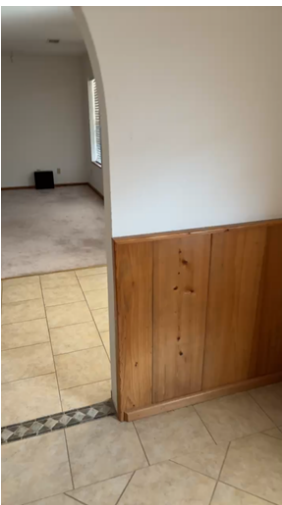
DEFICIENCY 8.1

Water Stains Noted

Evaluation, Repair: Water stains were observed at the walls/ceilings in the noted location. Elevated moisture was found in this area. Recommend having a certified contractor evaluate and repair accordingly.

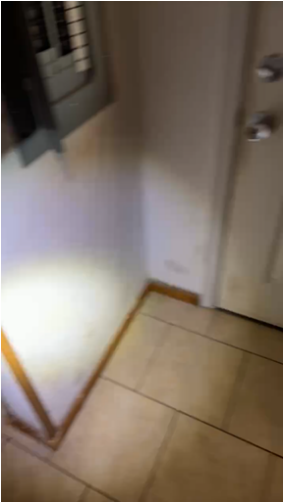
DEFICIENCY 8.2

Damage Noted At Wall/Ceiling

Repair: Damage and/or holes were noted in the walls/ceilings as noted, which should be repaired and repainted.

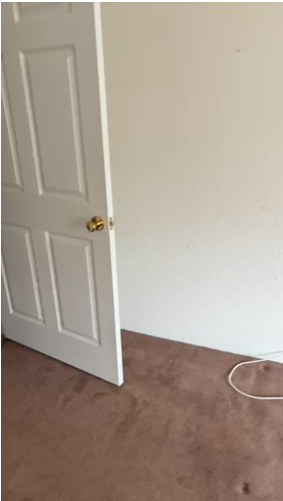
DEFICIENCY 8.3

Poor Drywall Finishes Noted

Improve: Lifting tape, seams, cracks, or other signs of poor drywall finish work were noted. These issues appear to be primarily cosmetic in nature and not indicative of structural issues. Repair and monitor for future recurrence.

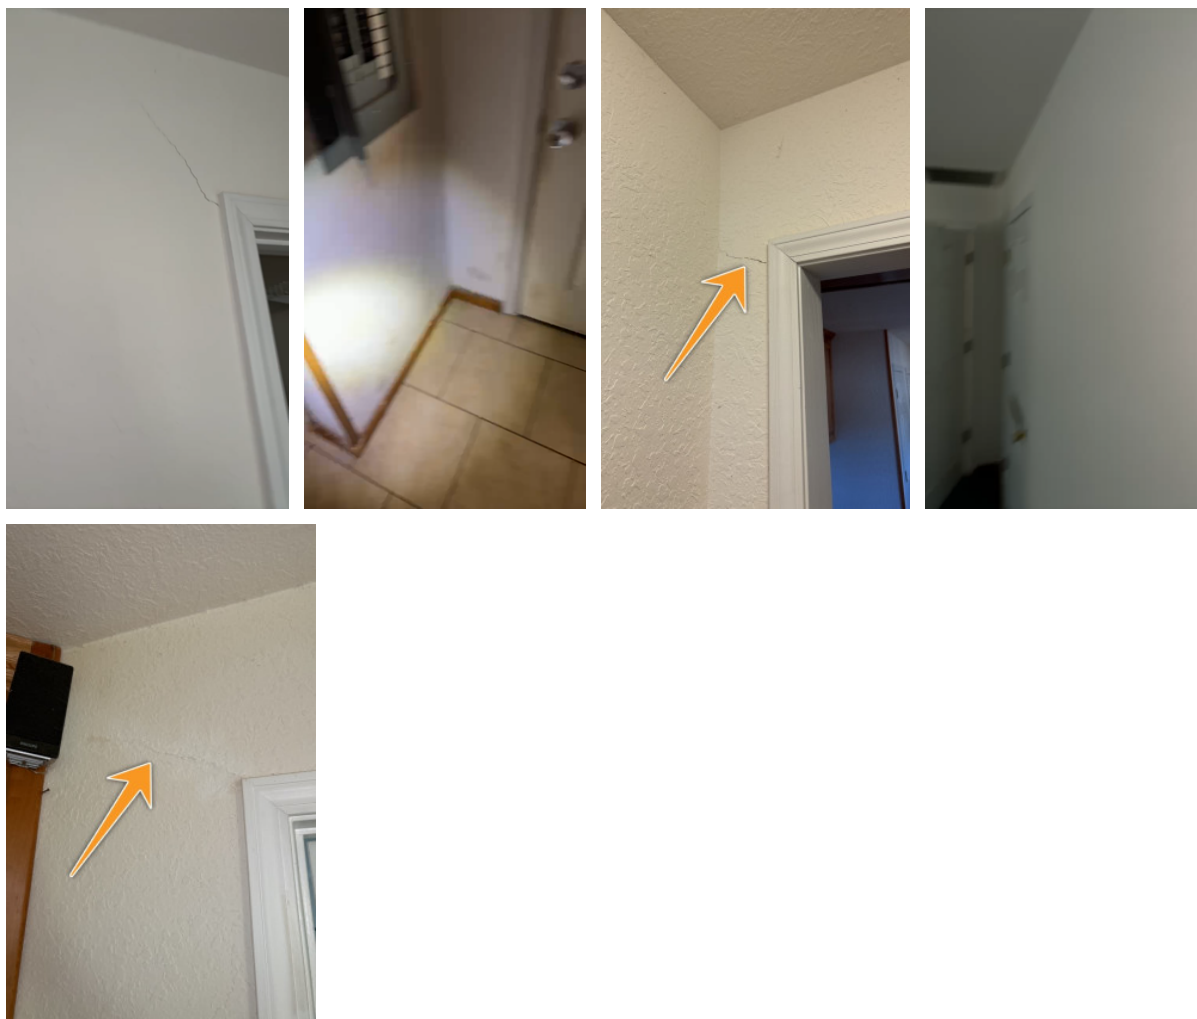
DEFICIENCY 8.4

Settlement Cracks Noted - Wall/Ceiling

Monitor: Signs of structural settlement were observed at the location(s) noted. If the cracks have not already been repaired, repair cosmetically and monitor for future recurrence.

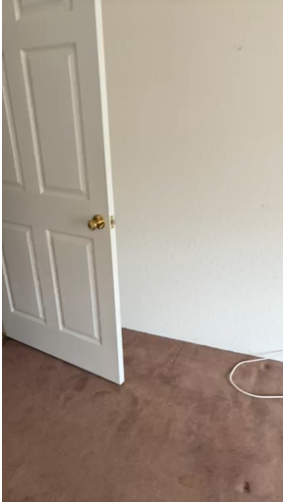
DEFICIENCY 8.5

Shoe Molding Missing

Improve: Baseboard shoe molding is missing as noted and is recommended for sealing all open gaps between the baseboards and flooring.

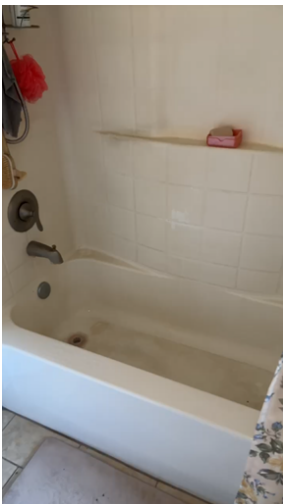
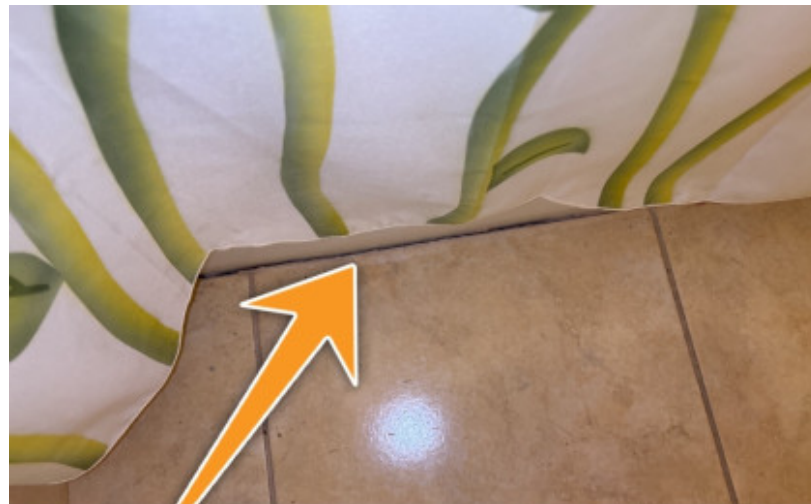
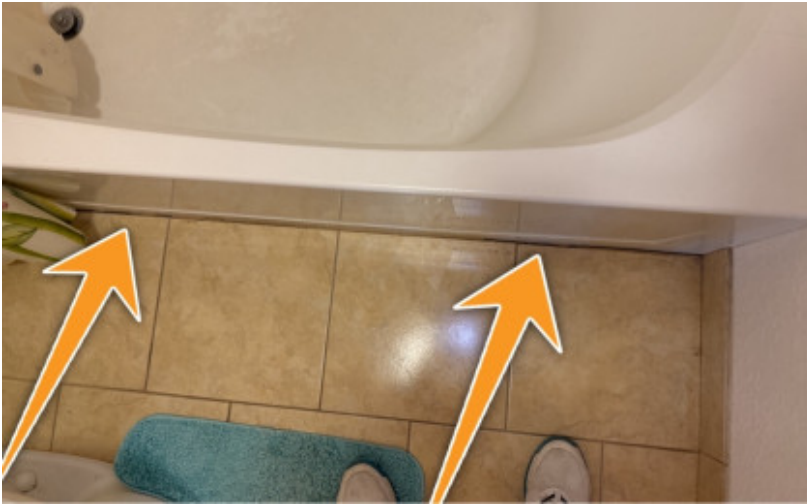
DEFICIENCY 8.6

Grout Repair

Repair: Cracked, deteriorated, and missing bathtub and/or shower enclosure grout and caulk as noted and should be replaced to prevent moisture intrusion into the wall and floor framing.

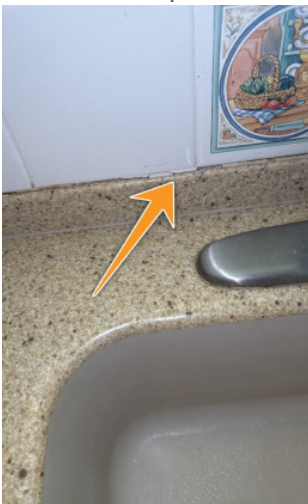
DEFICIENCY 8.7

Caulk Backsplash

Improve: The backsplash at the counters needs caulking and sealing to prevent moisture intrusion into the walls, especially around the sink.

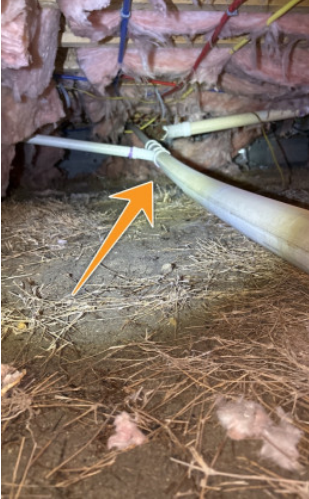
DEFICIENCY 9.1

Poorly Supported Piping

Repair: Some of the water supply piping as noted lacks adequate support (typically required every 2-3 feet). This condition could lead to future leaks at the joints and excessive vibration of the piping. Have a plumber check all piping support in this area and make repairs as necessary.

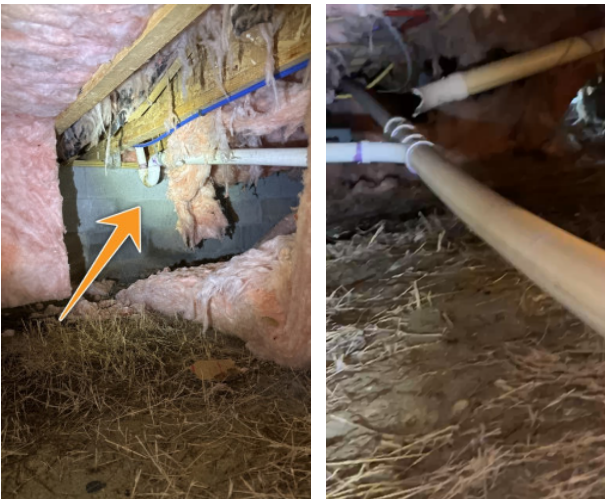
DEFICIENCY 9.2

Drain Piping Leaking

Repair: The drain piping as noted is leaking. A plumber should check all piping and

connections in the area and make repairs as necessary.

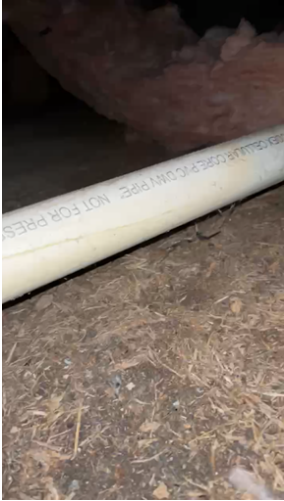
DEFICIENCY 9.3

Undersize Waste Line

Repair: The waste piping as noted does appear to be smaller than typically found. Small main waste lines can cause potential restrictions. No slow drains were found at the time of the inspection. Recommend having a certified contractor evaluate the waste line size and slope and improve accordingly.

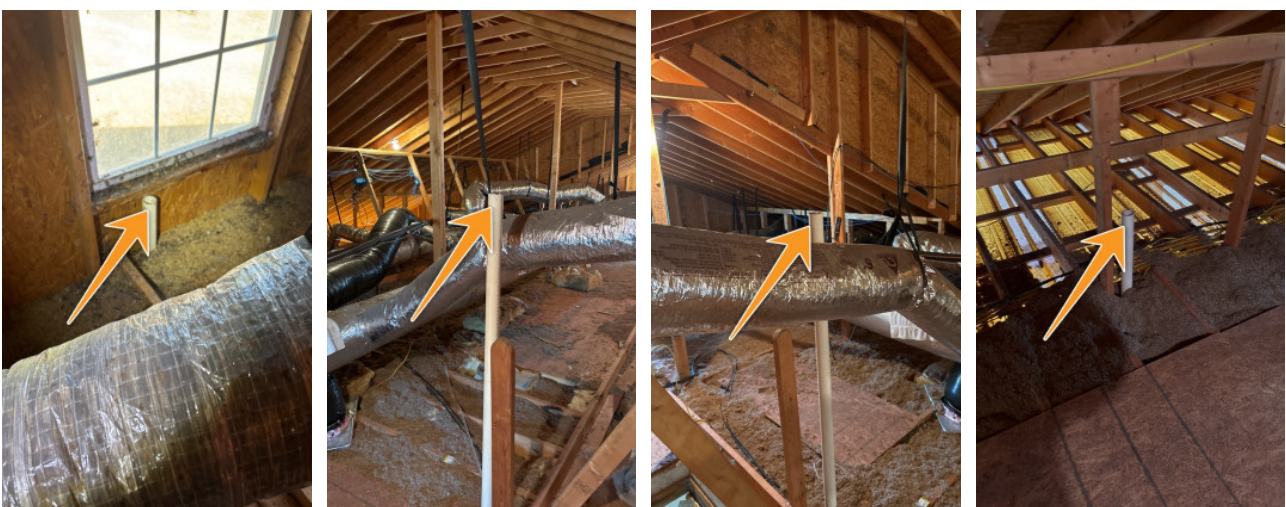
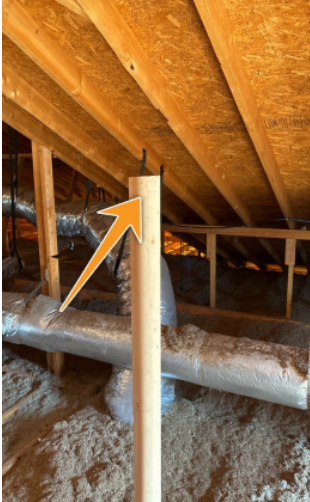
DEFICIENCY 9.4

Vent Terminates In Attic

Repair: It appears that a plumbing vent stack is terminating into the attic as noted. This condition could allow sewer gas to collect in this area if the stack is active. A plumber should investigate this condition and either extend the vent through the roof or otherwise have it capped off if not in use.

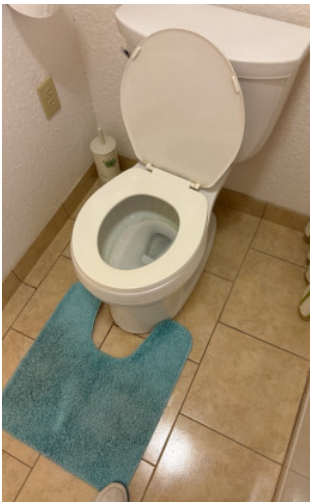
DEFICIENCY 9.5

Toilet Loose

Repair: The toilet at the location noted was loose and needs repair. Have the wax ring checked for leaks and the toilet properly bolted to the floor.

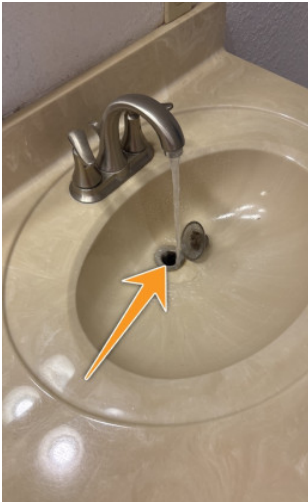
DEFICIENCY 9.6

Sink Stopper Repair

Repair: The sink stopper(s) as noted did not function properly or are missing and need repair or replacement altogether.

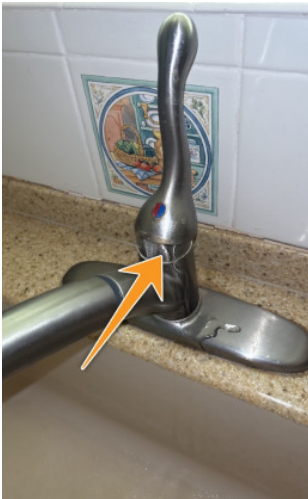
DEFICIENCY 9.7

Faucet Leaks

Repair: Some of the faucets leak slightly as noted. This typically indicates that washers inside the handles or valves need replacement.

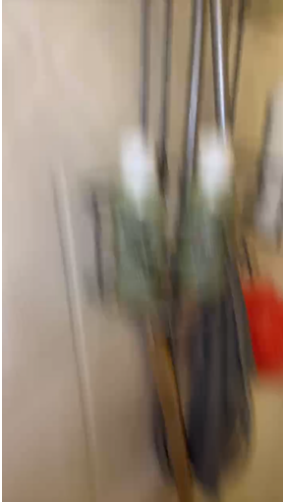
DEFICIENCY 9.8

Leak At Sink Drain

Repair: Leakage was noted at the sink drain. Consult a plumber or qualified handy person for repair.

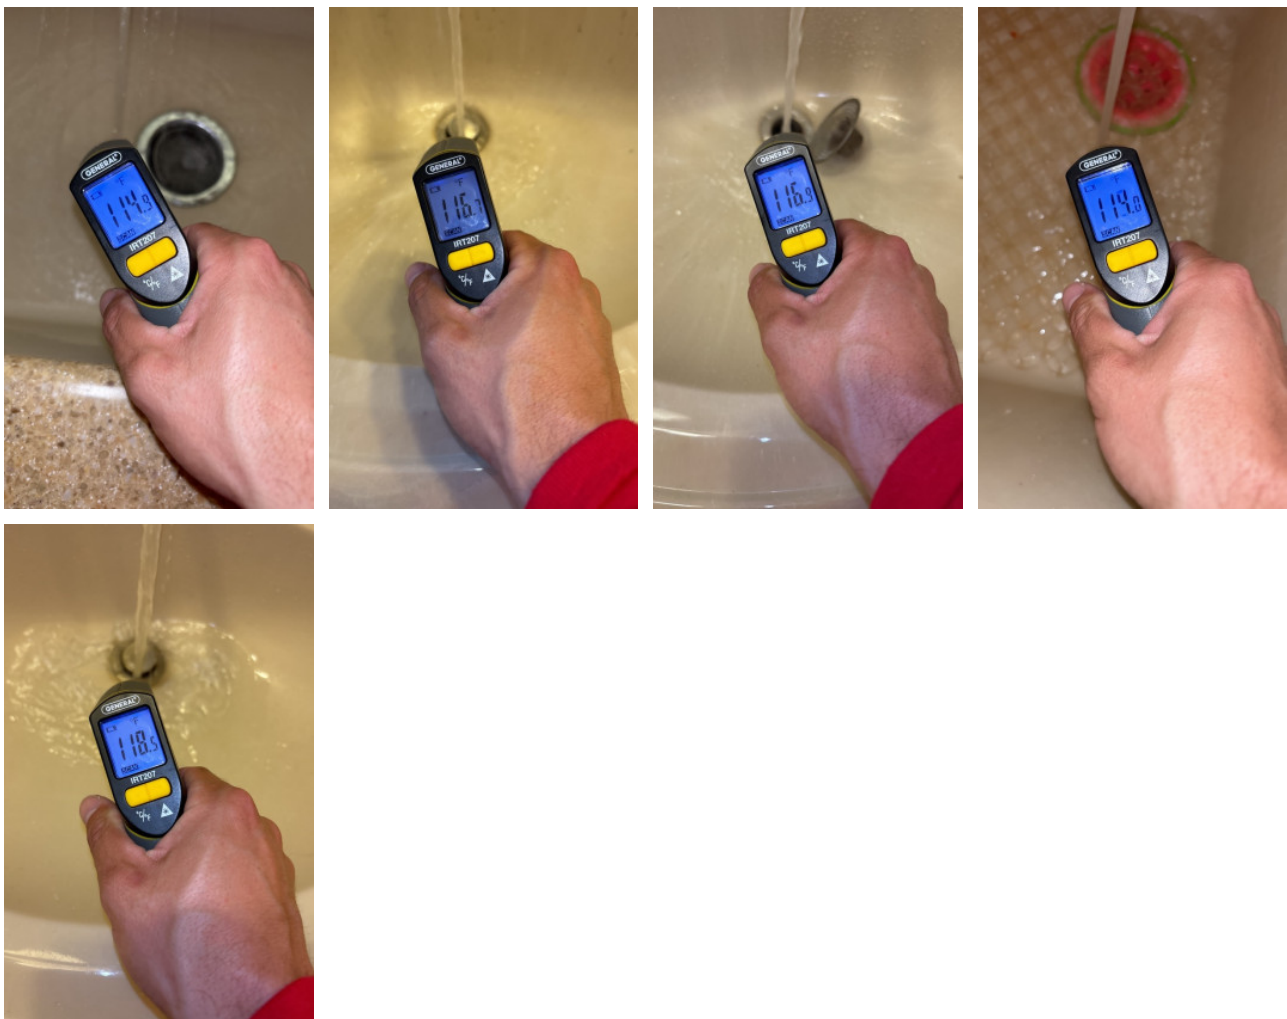
Water Temperature Normal

Monitor: Water temperature measured at or below 120 degrees Fahrenheit, the threshold for scald hazards. No action necessary, FYI only.

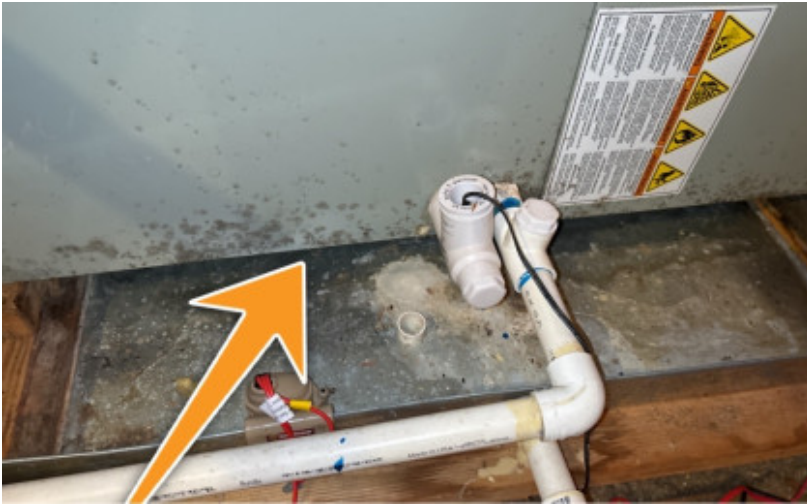
DEFICIENCY 11.1

Clean Microbial Growth

Repair, Safety Issue: Evidence of possible microbial growth and mildew was noted at the furnace at the location pictured, which should be cleaned as needed by an HVAC service company. All ductwork and other components should be checked for further growth and cleaned as needed.

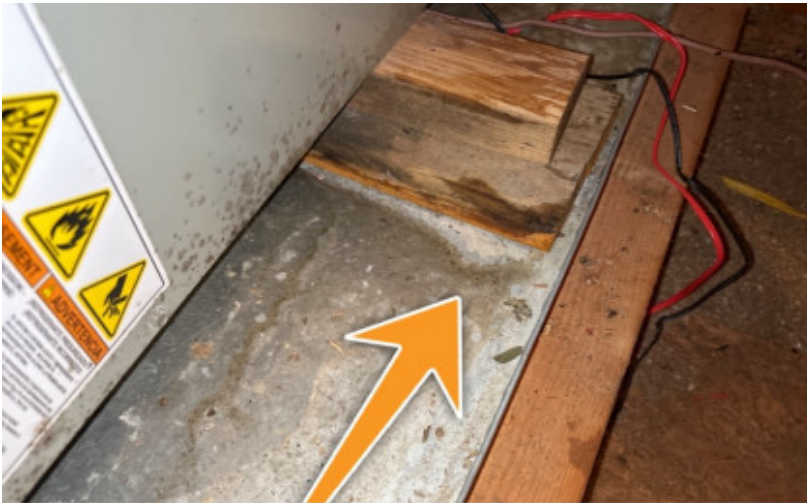
DEFICIENCY 11.2

Water Staining in Overflow Pan

Monitor, Possible Repair: Water staining in the overflow pan was noted. Recommend continuing to monitor for any water buildup in the overflow pan. It is recommended to have all HVAC components evaluated once a year for routine maintenance and cleaning.

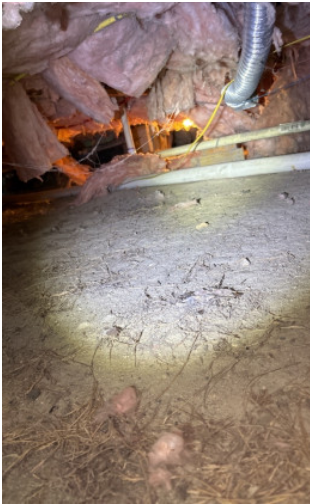
DEFICIENCY 12.2

Add Moisture Barrier

Repair: A moisture barrier should be installed on the crawl space floor to limit humidity build-up in the area, which can promote termite infestations and mildew growth.

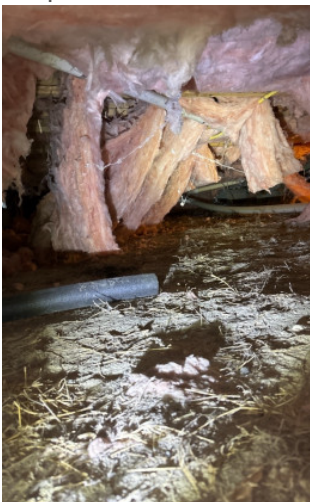
DEFICIENCY 12.3

Displaced Insulation In Crawlspace

Repair: Insulation was missing or displaced. Adding proper Insulation will increase the efficiency of the home. Have a contractor or qualified handy person reposition and replace insulation where necessary.

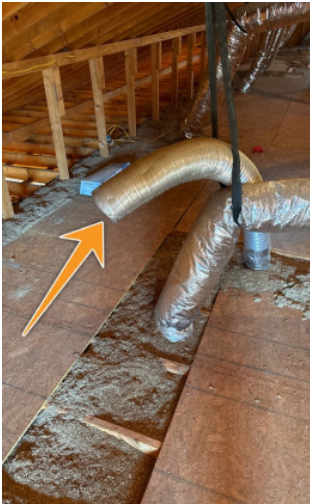
DEFICIENCY 12.4

Vent Bath Fan To Exterior

Improve: Bath fans discharging into the attic as noted should instead be vented to the building exterior to limit humidity build-up in the attic.

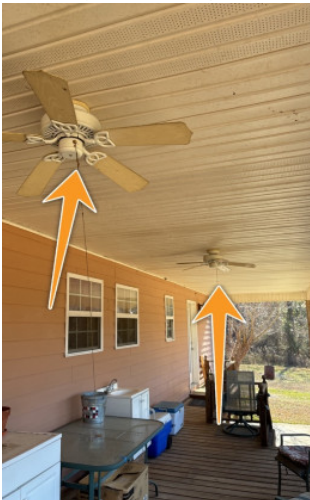
DEFICIENCY 12.5

Ceiling Fan Inoperative

Repair: The ceiling fan did not operate when tested using normal controls. Consult the seller for additional information, or consult an electrician for replacement of the unit.

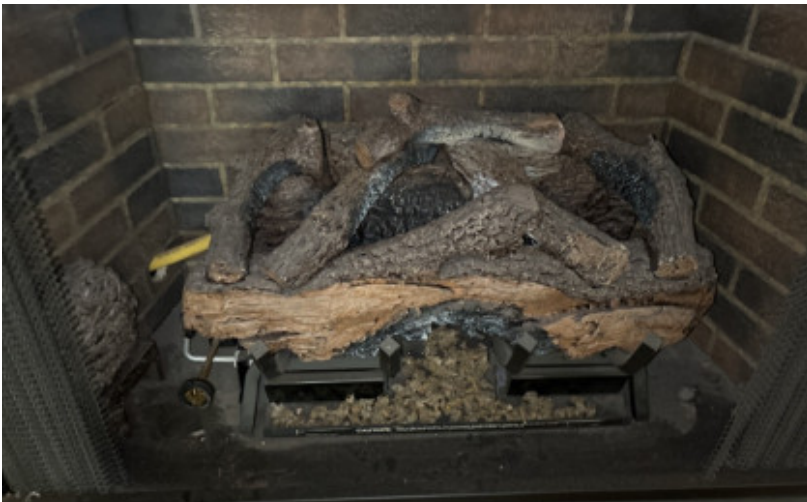
DEFICIENCY 13.1

Fireplace Cleaning (With Gas Logs)

Repair, Safety Issue: The fireplace chimney could use cleaning due to the presence of built-up soot in the chimney from the gas logs. All flues and gas connections should be checked on an annual basis for proper safety.

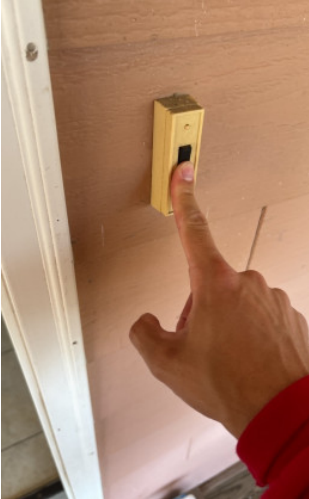
DEFICIENCY 13.2

Doorbell Inoperative

Improve: The door bell at the location pictured did not activate when tested and may need repair or replacement.

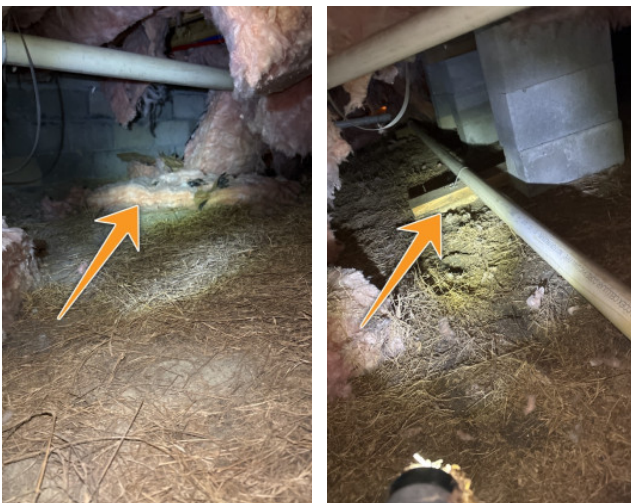
DEFICIENCY 14.2

Wood Debris In Crawlspace

Repair: All wood debris and/or trash should be removed from the crawlspace. Organic debris in the crawlspace increases risk of termite infestations.
